# Load Test Result (MCS Chart)

| Brand | Hoppecke | Volt. | 48 | Ah | 775 | Cells | 24 | Standby Volt. | | Type | | Year/Manuf. | 2008 | Ambient Temp. | |

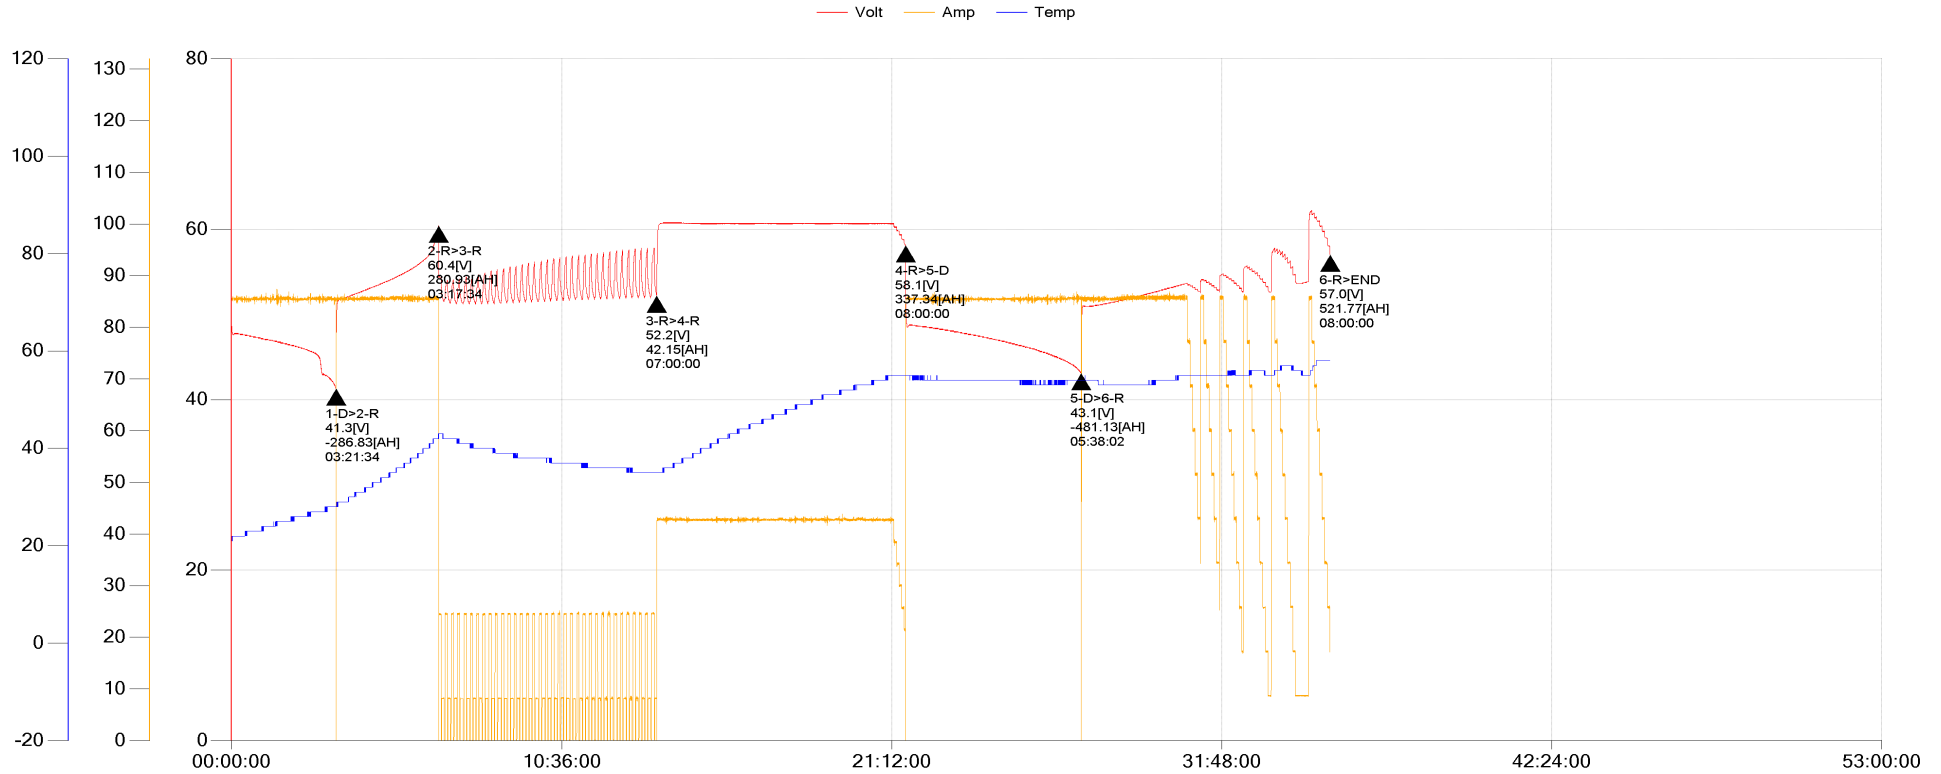
| Index | Method | Pulse | Setup Time | Elapsed Time | Setup Volt | Max Volt | Min Volt | Setup Amp | AH | Temperature |
| 1 | Discharge | 1 | 12:00:00 | 03:21:34 | 41.3 | 51.7 | 41.3 | 85.3 | -286.8 | + 28 |
| 2 | Restoration | 1 | 06:00:00 | 03:17:34 | 60.4 | 60.4 | 44.5 | 85.3 | 280.9 | + 43 |
| 3 | Restoration | 4 | 07:00:00 | 07:00:00 | 62.4 | 57.8 | 51.2 | 24.4 | 42.2 | + 35 |
| 4 | Restoration | 2 | 08:00:00 | 08:00:00 | 62.4 | 60.8 | 52.4 | 42.6 | 337.3 | + 55 |
| 5 | Discharge | 1 | 12:00:00 | 05:38:02 | 43.1 | 56.5 | 43.1 | 85.3 | -481.1 | + 54 |
| 6 | Restoration | 2 | 08:00:00 | 08:00:00 | 62.4 | 62.2 | 46.1 | 85.3 | 521.8 | + 58 |
